Service Bulletin: 2

Battery Service

Product affected: All versions of the Razor Drive Systems

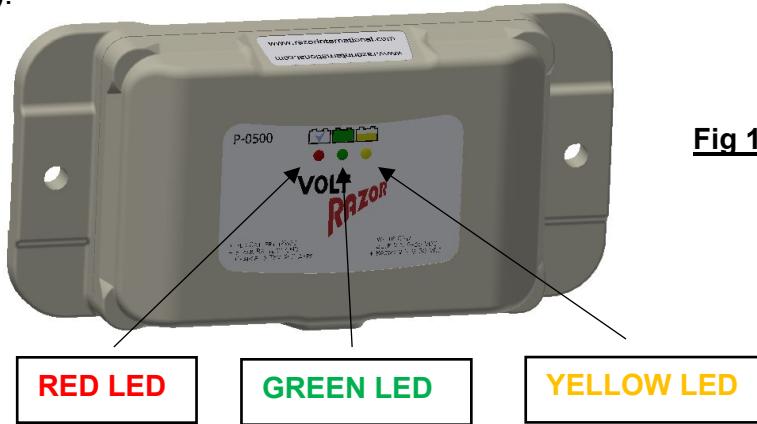
Fig 1

1. If the battery is not receiving a charge (RED LED does not illuminate), then the voltage supply could be a fault due to the condition of the connectors of the harnesses or failure of the battery charger (refer **Fig 1**).

RED LED	This indicates that voltage supply is connected.
YELLOW LED	This indicates that the battery is charging.
GREEN LED	This indicates that the battery is fully charged.

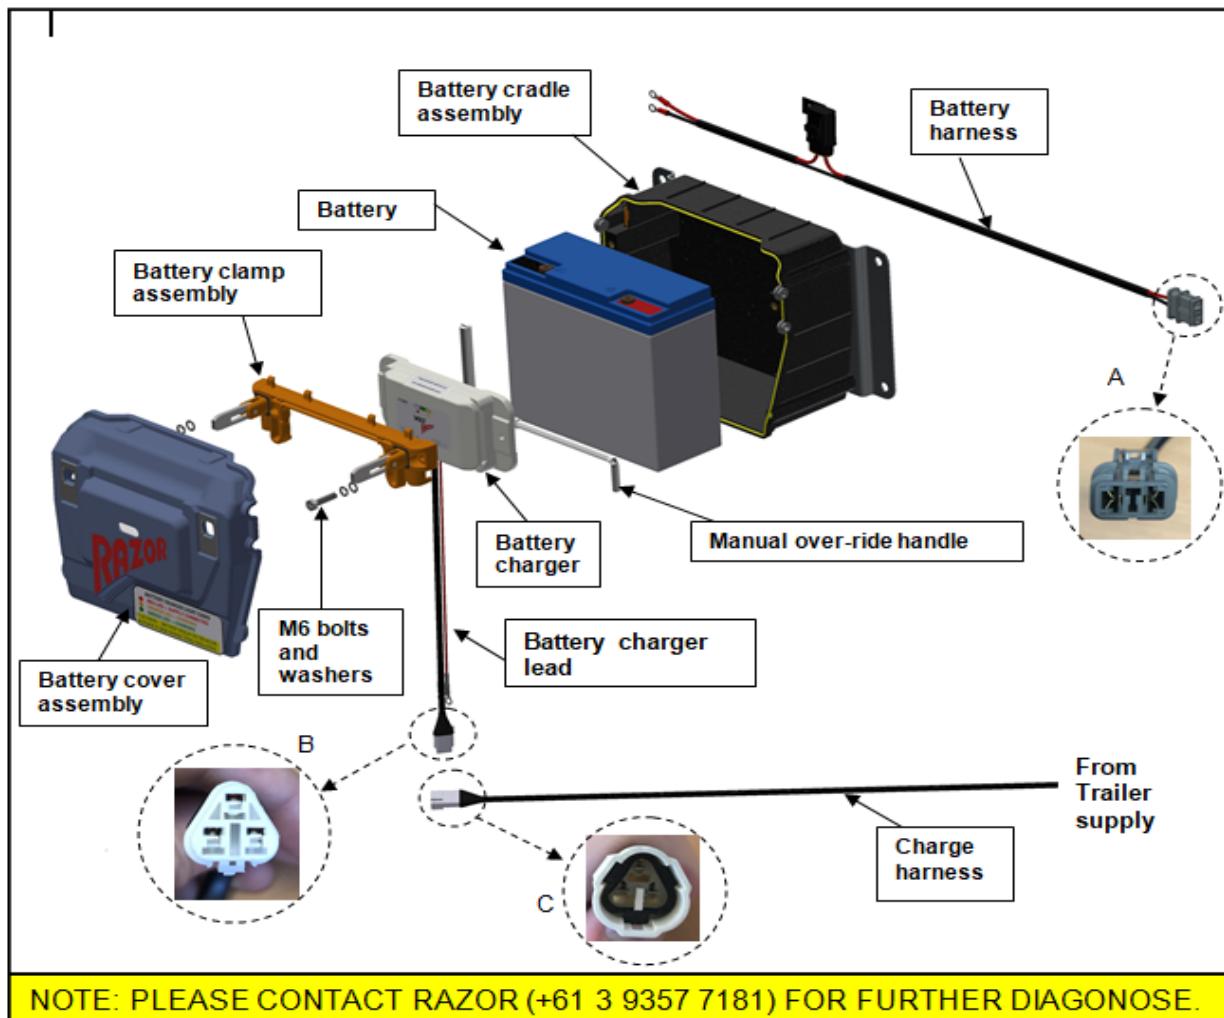
Fig 2

- With ongoing use there may be dirt or corrosion in the plugs of battery harness and/or charge harness (which leads to loss of voltage across harness connectors). If so, they will need to be cleaned & sprayed with water inhibitor (as per **Fig 2** details of plugs as per below view **A**, **B**, **C**).
- If the battery has failed, then the battery needs to be replaced as per **Fig 2**.
Note: For good battery life, the battery should never be left uncharged for any period.

Note: If two LEDs (RED & YELLOW or RED & GREEN) are not illuminated as per **Table 1** is showing, when the power supply from truck is connected (and Battery is above 9 Volts), then the battery charger needs to be replaced as per **Fig 2**.
