Service Bulletin: 6

Revision: 1

Razor International Pty Ltd, Campbellfield VIC

Motor Brake Service

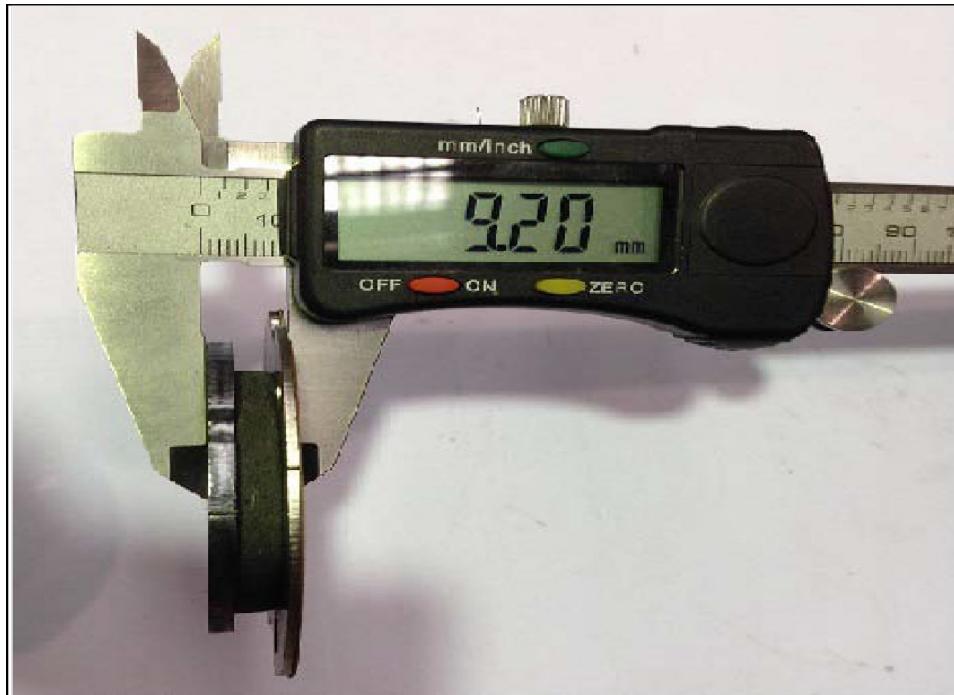
Symptom: With ongoing use the brake pad will wear and if it is found that it is not holding, then it will possibly need to be shimmed by adding a 0.26mm brake shim.

Note: The combined working thickness for the brake back plate, the brake pad and the brake plate should not be less than 9.15mm and not greater than 9.25mm. Refer image below.

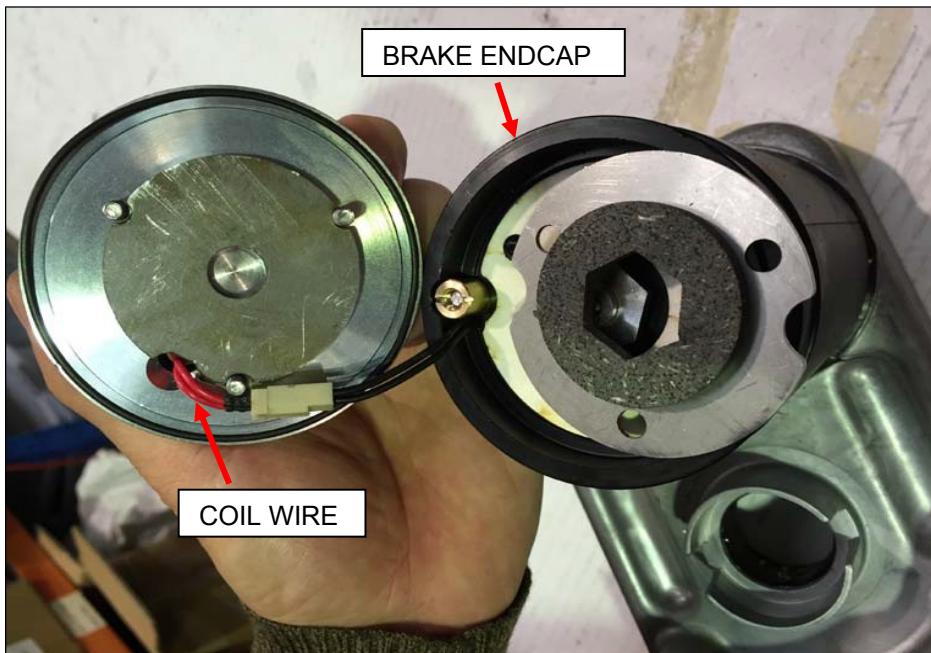
Caution: The coil wire needs to be located inside the brake endcap (as per detail below) in case the wire is chaffed when installing.
