Service Bulletin: 9

Revision: 1

Razor International Pty Ltd, Campbellfield VIC
service@razorinternational.com
1300 555 865

Brake Seal Service

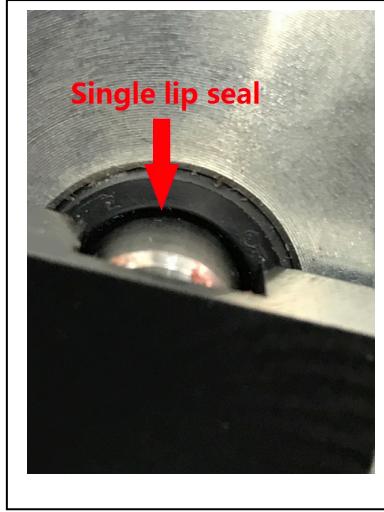
FIG 2

Symptom: Due to the recent supplier manufacturing fault, instead of using the double lip seal, the brake end body has been fitted with a single lip seal.

1. Firstly, lift the brake toggle and visually check the structure of the seal. **Fig 1** shows the correct seal that is fit onto the brake coil housing, which is a double lip seal. **Fig 2** shows the wrong seal that is fit onto the brake coil housing, which is a single lip seal.
2. Then, if you found the brake mechanism with single lip fitted, please replace with a correct brake rear housing

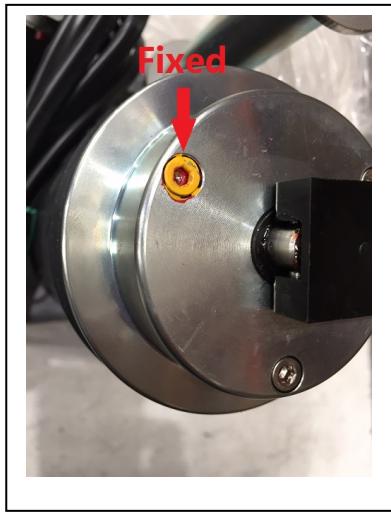
FIG 3

Note: Detailed replacement procedures refer **Fig 4** in the next page. The brake housing with a yellow mark on the bolt **Fig 3** means the brake mechanism is fixed by Razor.
